# imbio

## RV/LV

v3.0.0

# IMBIO CT RV/LV USER MANUAL

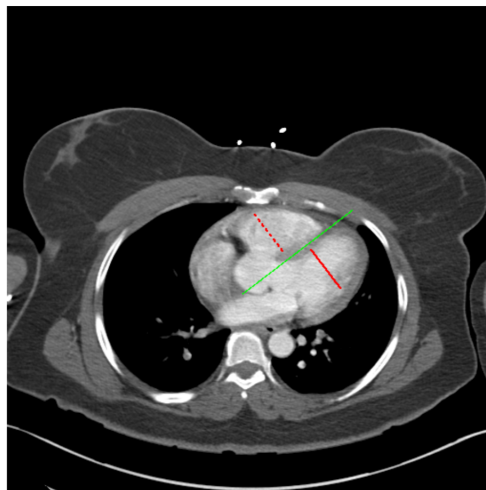
Largest Right Ventricle Diameter Located on Slice 143

Largest Left Ventricle Diameter Located on Slice 153

Figure 4: Example of ventricle images in RV/LV Summary Report.  
The left image displays the slice of the right ventricle with the largest diameter.  
The right image displays the slice of the left ventricle with the largest diameter.

The report displays two ventricle slice images from the RGB overlay. The slices selected for the report are the slices with largest ventricular diameter for the left and the right ventricle. And example of the image in the report is shown below in Figure 4.
