imbio

RV/LV

v3.1.1

IMBIO CT RV/LV USER MANUAL

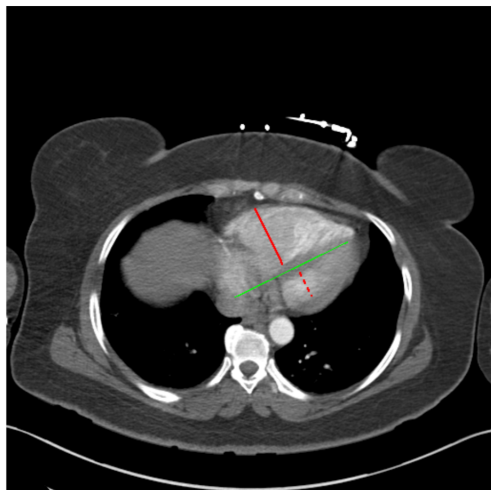
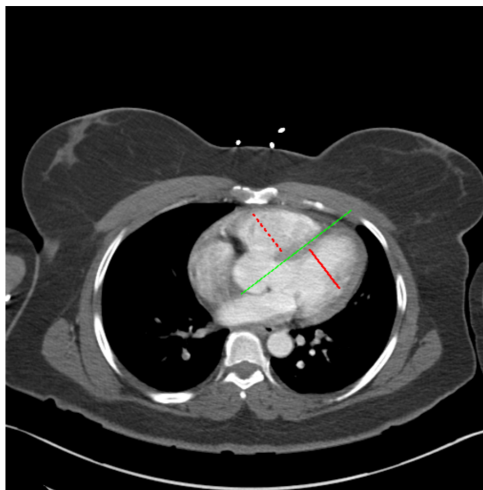
Largest Right Ventricle Diameter Located on Slice 143

Largest Left Ventricle Diameter Located on Slice 153

Figure 4: Example of ventricle images in RV/LV Summary Report. The left image displays the slice of the right ventricle with the largest diameter. The right image displays the slice of the left ventricle with the largest diameter.

The report displays two ventricle slice images from the RGB overlay. The slices selected for the report are the slices with largest ventricular diameter for the left and the right ventricle. And example of the image in the report is shown below in Figure 4.

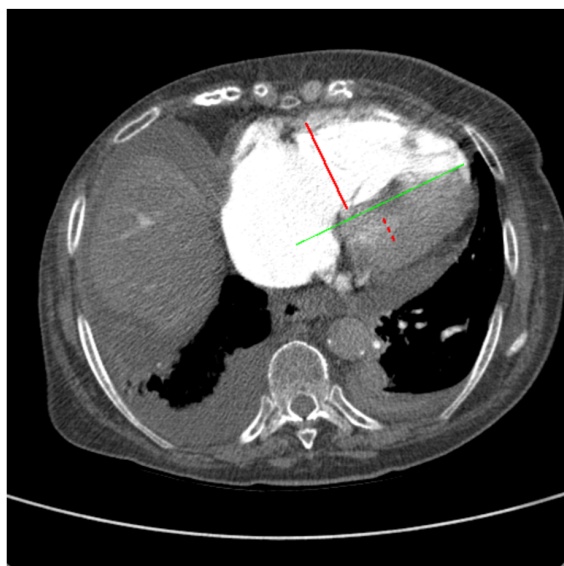
2. Poor Image Contrast: This error can be identified by viewing the RV/LV Annotated Image Series or the Report. In Figure 6 below, there is minimal contrast between the cavity and the surrounding myocardium of the left ventricle. This is caused by a poorly timed CTPA acquisition and can impact both the automated algorithm and the visual QA process.

Figure 6: Poor contrast between the cavity and the myocardium can complicate the analysis.

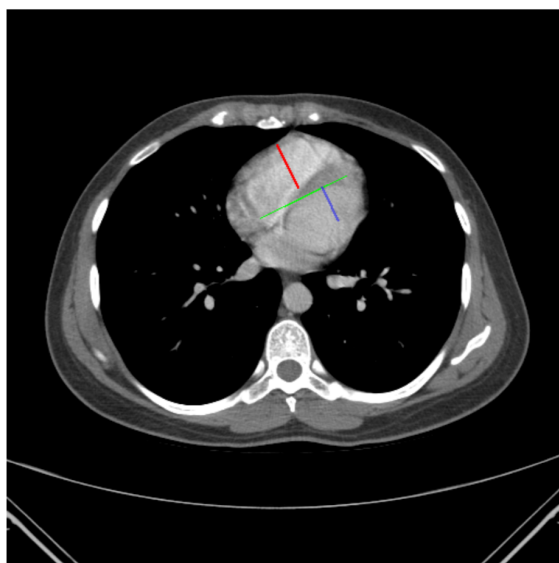
3. Poor Septum Detection: This error can be identified by viewing the RV/LV Annotated Image Series or the Report. In Figure 7 below, the interventricular septum (green line) is poorly detected. The ventricular measurements are made perpendicular to the detected septum, so a poor septum detection can impact the final ventricular measurements and ratio.

Figure 7: The interventricular septum has been identified incorrectly, leading to a poor segmentation.
